The
LaQUE CENTER
FOR CORROSION TECHNOLOGY, INC.

**SEAWATER CREVICE CORROSION RESISTANCE OF
STAINLESS STEELS COATED WITH
SILANE AND ANTIFOULING PAINT SYSTEMS**

**FINAL REPORT
CONTRACT N00014-01-C-0177**

August 2002

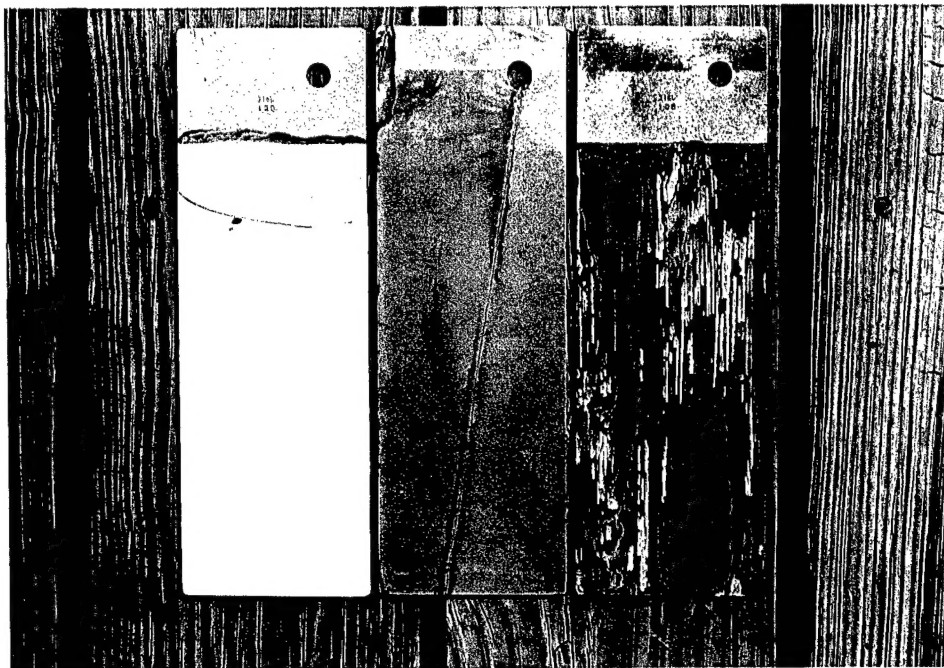
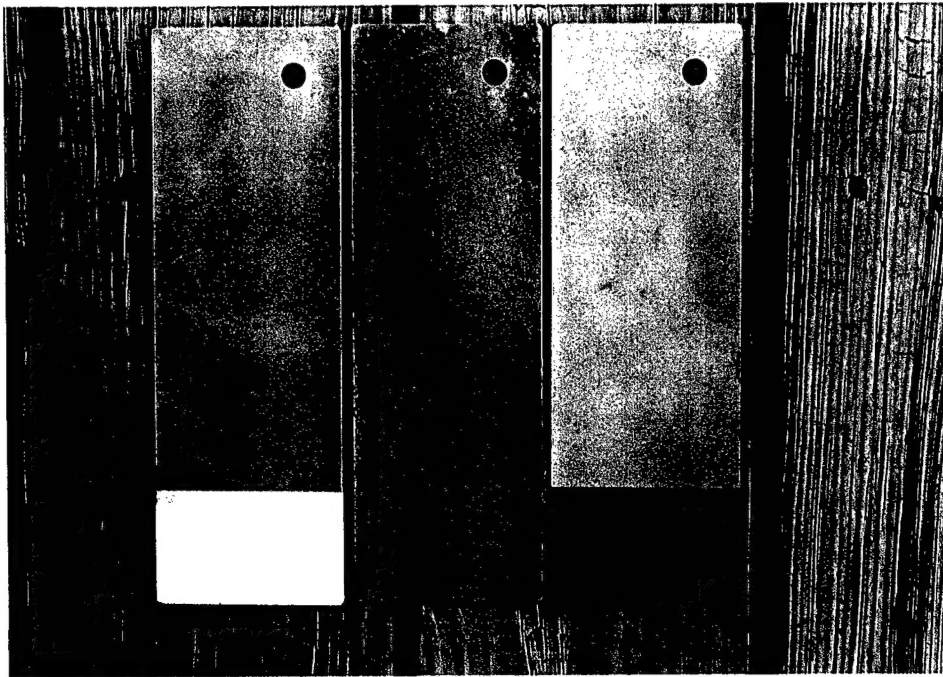
Figure ES-1. Comparative views of S31603 specimens partially coated with (left-right) epoxy, silane alone and silane + ablative-Cu and exposed for nine months.

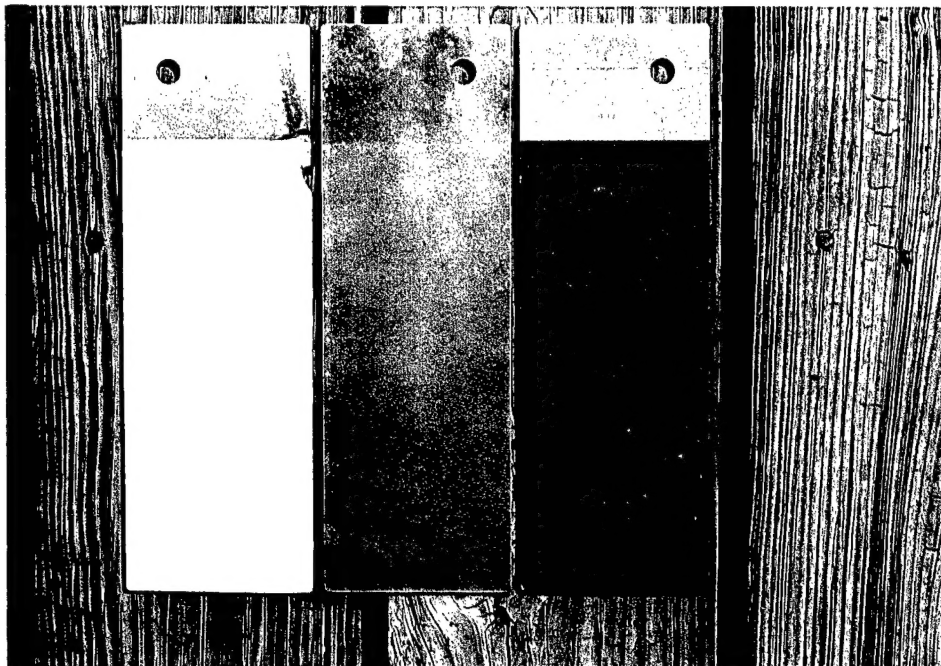
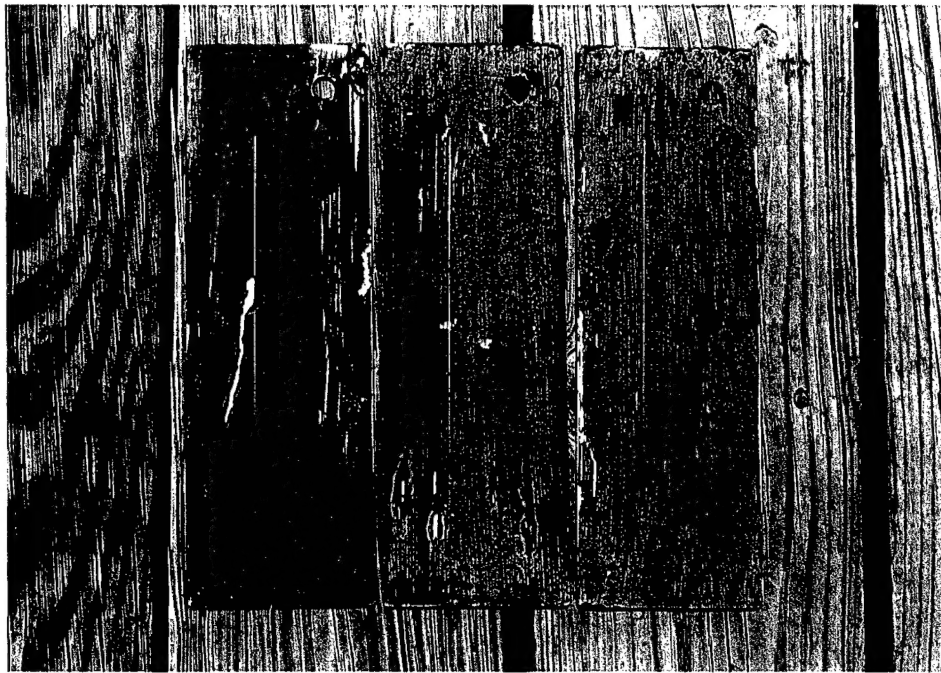
Figure ES-2. Comparative views of N08367 specimens partially coated with (left-right) epoxy, silane alone and silane + ablative-Cu and exposed for nine months.

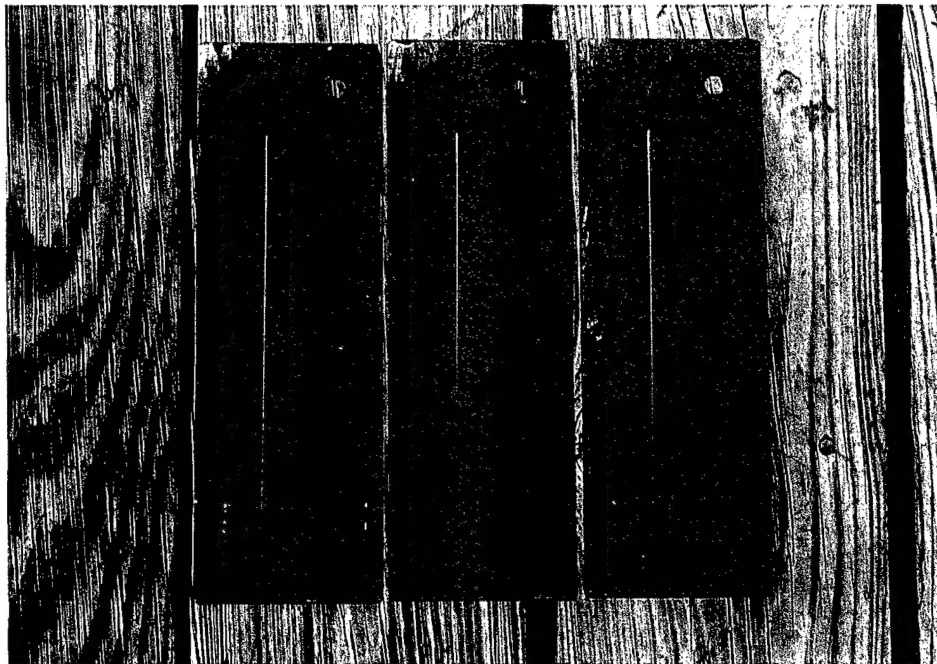
Figure ES-3. Comparative views of fully coated + scribed specimens exposed for nine months.
(Left-right: pretreated with Silane A, B and C)

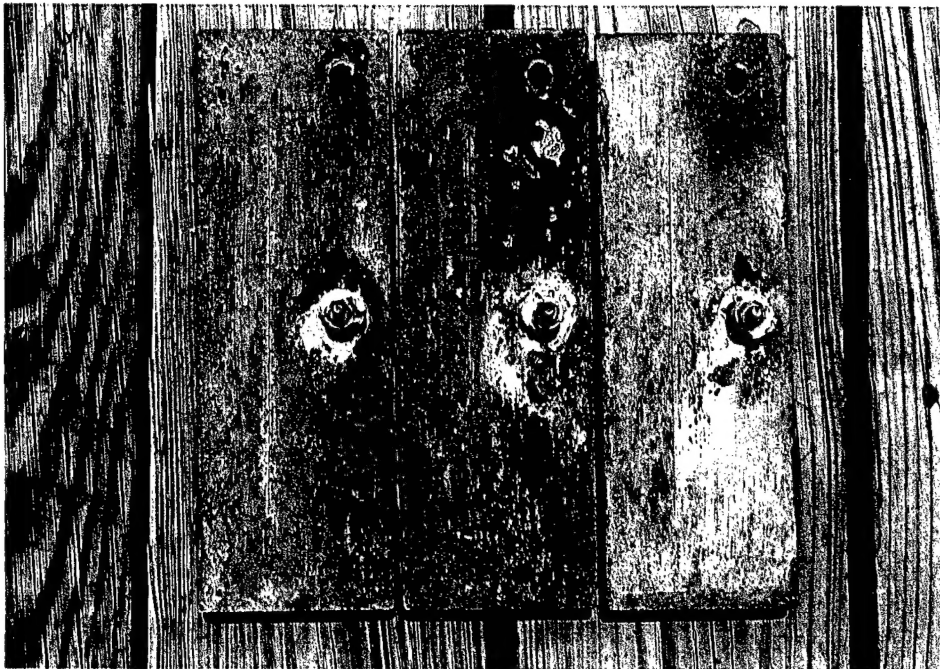
Figure ES-4. Representative view of fully coated + scribed specimens exposed for full nine months with zinc anode attachments.
(Shown N08367 (left-right) pretreated with Silane A, B and C.)

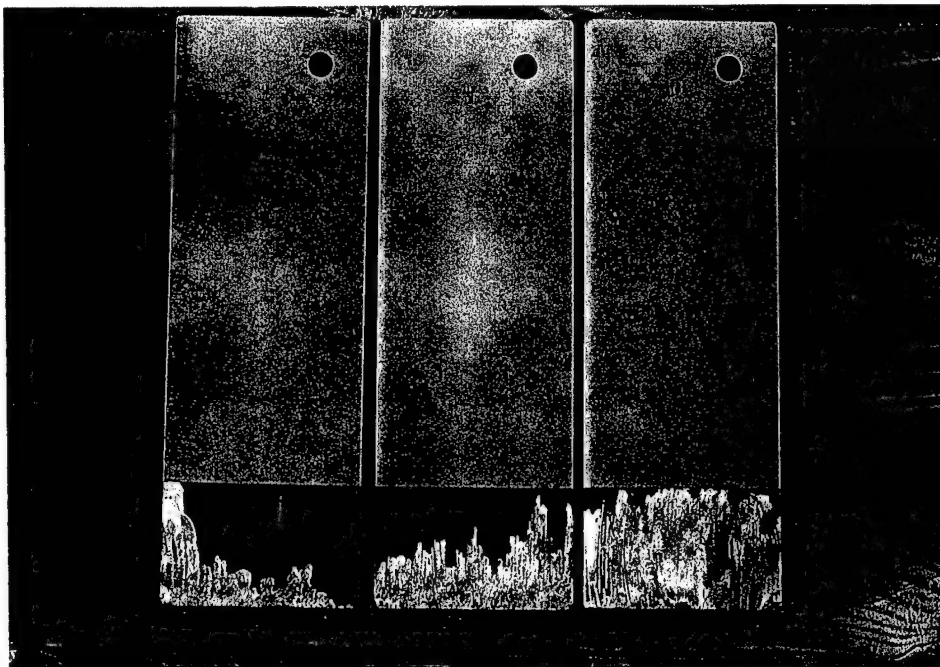
All S31603 specimens with 20% of the surfaces coated with silane + ablative Cu exhibited crevice-like attack. However, in contrast to the epoxy coated controls, the attack appeared to propagate inward from the edges and other initiation sites rather than from the primary interface with the bare metal. As shown by Figure 6, some influence of silane formulation on the overall extent of attack is apparent from the visual ranking $A < B < C$. Except for attack at apparent pit initiation sites, the attack beneath the silane + ablative Cu was relatively light, as contrasted with that found beneath the epoxy.

FIGURE 6 – After-cleaning view of S31603 specimens with 20% silane + ablative Cu (left to right: Silane A, B and C precoated)

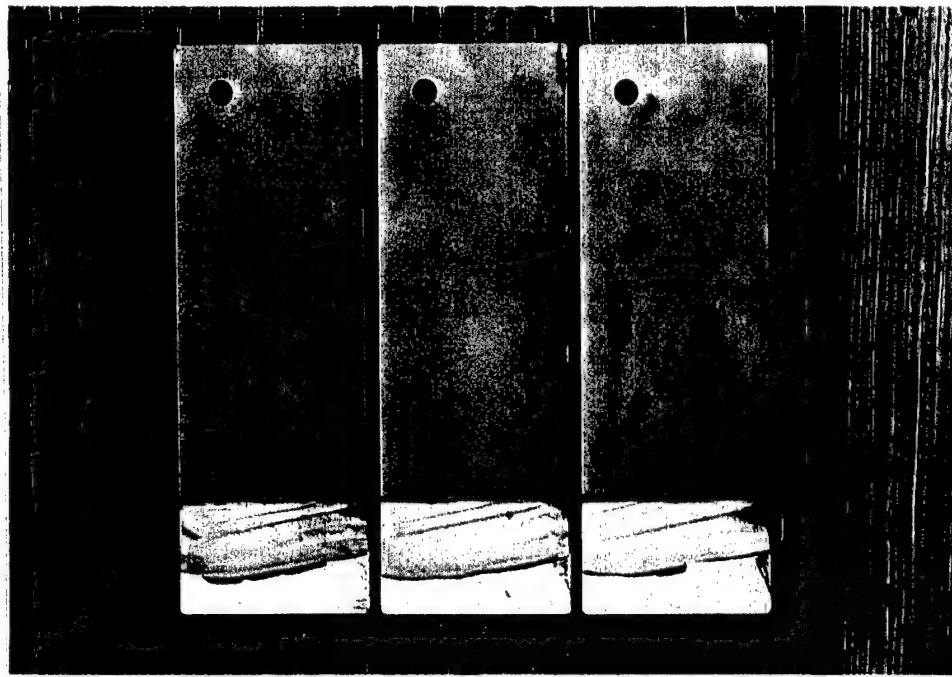
Figure 18.1 2609-04-019-1A

Figures 18.1 and 18.2 (20%), and Figures 19.1 and 19.2 (80%) show the extent of crevice corrosion which developed beneath the epoxy coating on S31603 specimens in nine months. Figures 18.3 and 19.3, respectively, compare the "worst case" condition of the preceding with that found on corresponding specimens removed after only three months.
